Largo, Florida

Monday, February 18, 2013

Inspection Information Sheet

Date of Inspection: Monday, February 18, 2013
at 9:00 am
Property Address: Largo, Florida
Inspection Type: Commercial
People Present: Client

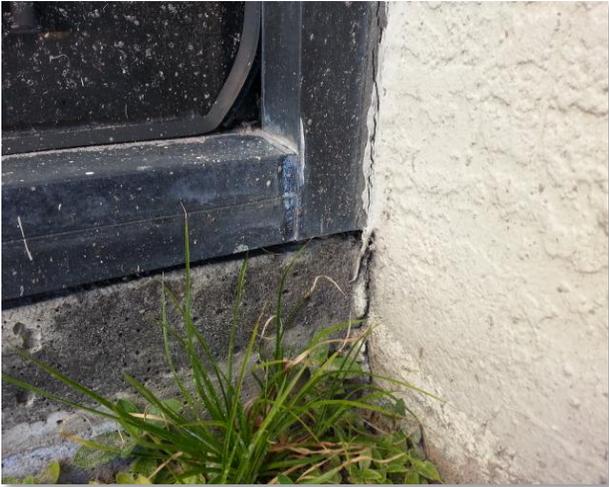
- 1 The sealant around the windows is deteriorated. It is particularly important to maintain the sealant around the perimeter of the windows at the intersection with the masonry. Improvements are needed at this time.
- 2 The two colored side panels on the sides of the front entry area appear to be EIFS (Exterior Insulated Form System) panels and it may be wise to replace them with traditional hard coat stucco in the future as they are prone to water intrusion issues and frowned upon by most insurance companies.

Deteriorated sealant at windows

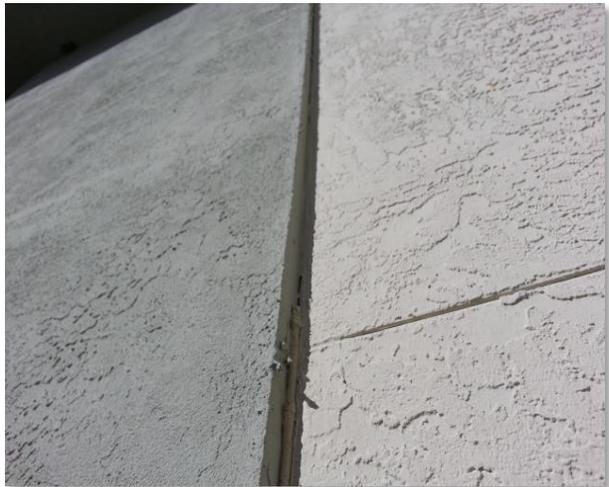
2

EIFS panels are poorly sealed and are prone to water intrusion

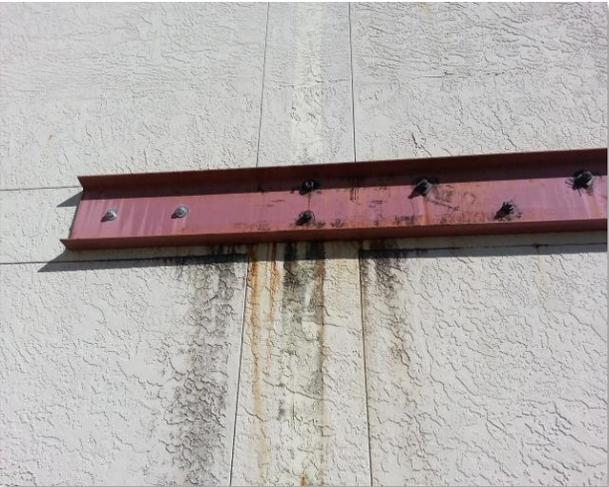
Steel ledger on the south wall should be removed

- 2 I recommend removing the rusted ledger board from the SE corner of the building.
- 3 Improve the seal around the east wall bay door trim and repair the damaged stucco as needed.

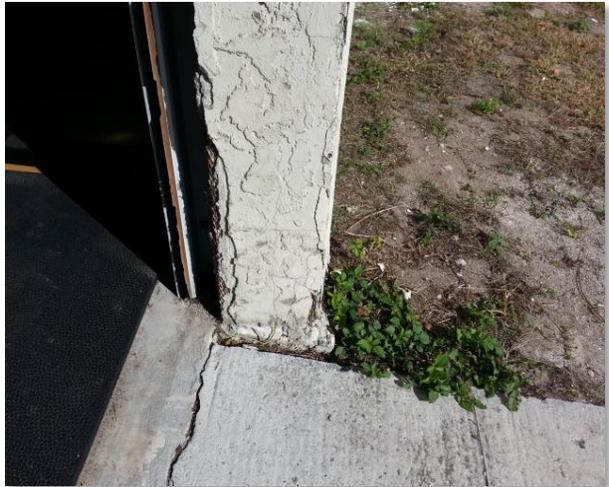
4

East side bay door frame is damaged

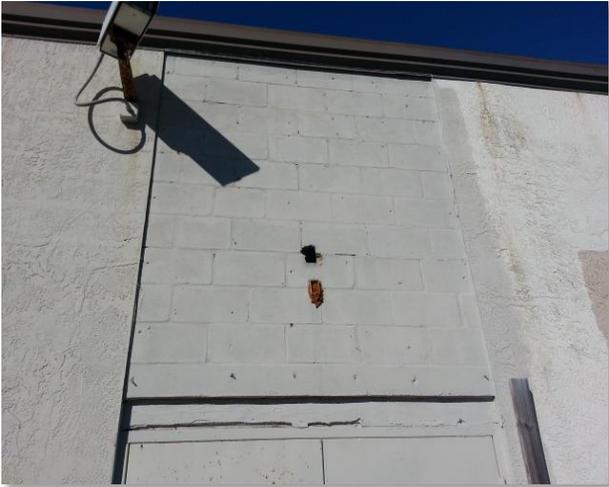
Example of unfinished facade of the accessory structure

- 4 Wood siding on the north and south wing stairwells is badly deteriorated and needs to be repaired or replaced.
- 5 Several areas of unfinished wall exterior were noted on the accessory structure. These areas should obviously be carefully finished and sealed to insure a watertight building envelope.

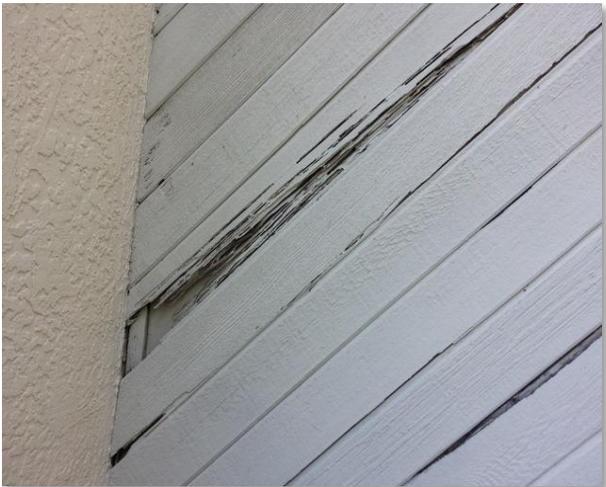
6

Example of damaged wood panels on stairwells

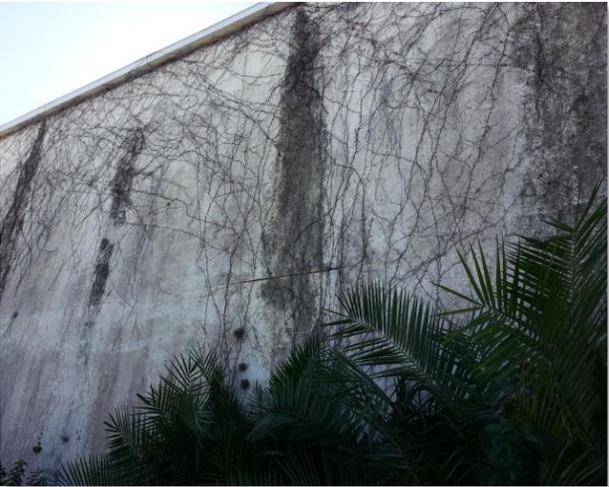
7

North wall is in a very poor state

- 6 Very heavy plant growth and numerous cracks on the exterior north wall of the building were noted. This wall has been neglected through the foreseeable past. I strongly recommend fully cleaning this wall and carefully preparing it for paint. Anticipate that repairs will be needed to corner bead and control joints and at several of the more severe stucco cracks that have accepted moisture for many years. Some V cutting and masonry patching will be necessary on several of the more pronounced cracks.

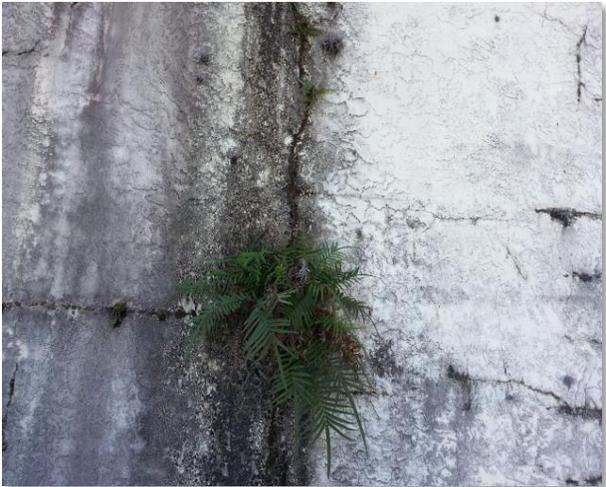
8

Heavy plant growth and algae on the north wall indicates extensive moisture intrusion

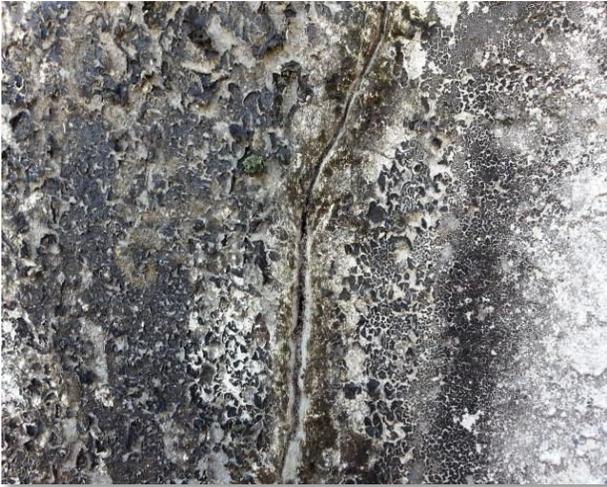
9

Example of deeper crack that will require appropriate patching

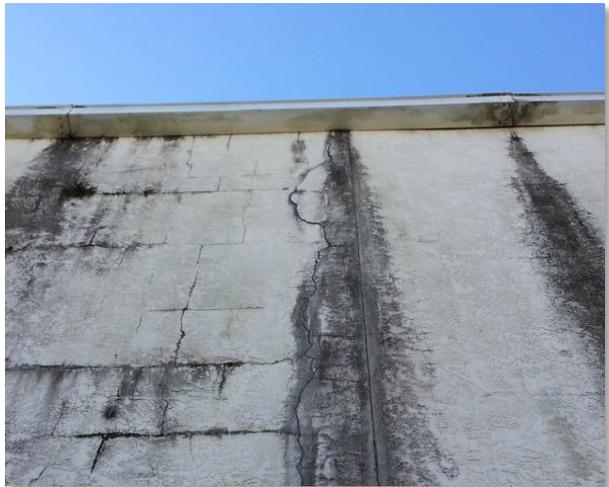
10

Anticipate loose stucco at several areas that will need to be removed and patched

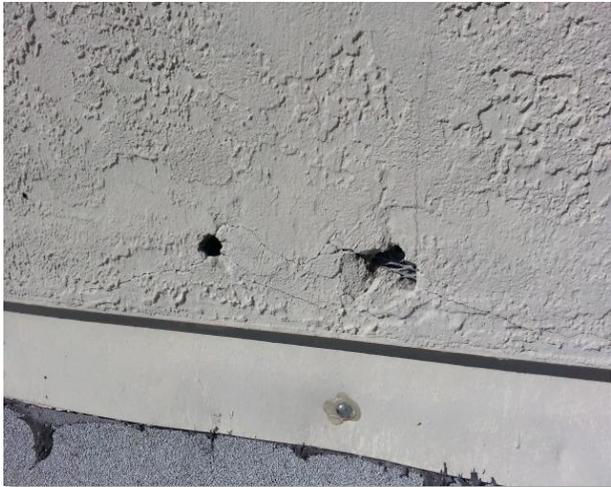
11

Damaged stucco on the upper east wall at the stairwell roof

- 7 There is some damaged stucco on the upper level wall over the east wing stairwell that needs to be repaired.
- 8 Scuppers and downspouts are missing from the south wall east side roof drains. These drains need to be better flashed and sealed and scuppers and downspouts need to be installed.

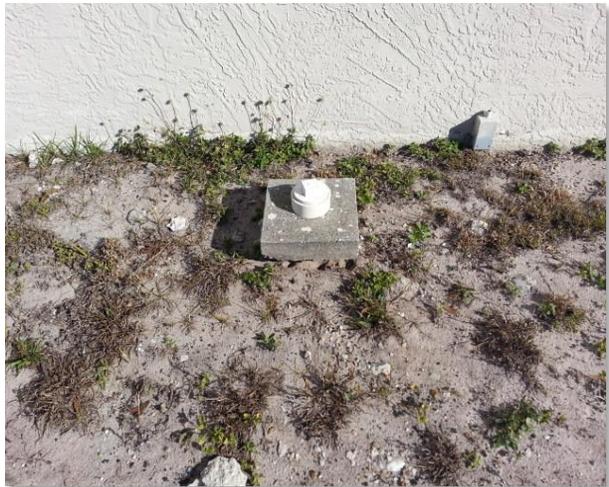
- 1 Fairly extensive soil erosion has occurred in the flower beds around the front of the building. It appears that approximately 3 to 4 inches of soil erosion has occurred over the years near the perimeter of the structure. I strongly recommend improving the grading and installing a ground cover that will resist future erosion.
- 2 Hydrostatic pressure is starting to affect the integrity of the built up planters on the front of the building. These planter walls are starting to shift. It would be wise to consider excavating soil from the interior of the planters in order to be able to drill drainage holes and install filter material to help reduce future hydrostatic pressure.

Example of about 4" of soil loss around the building

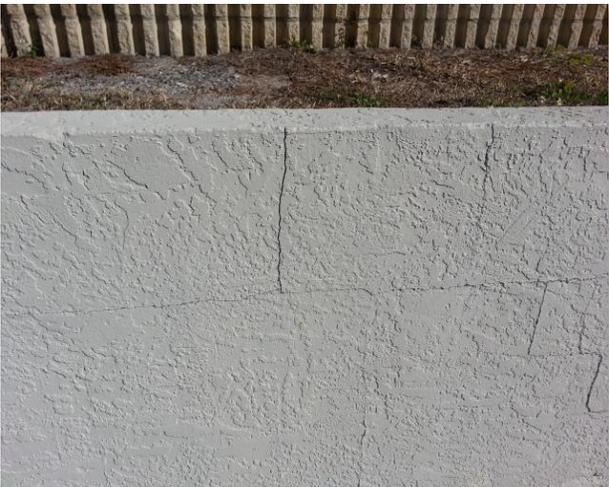
3

Movement to the front wall planters

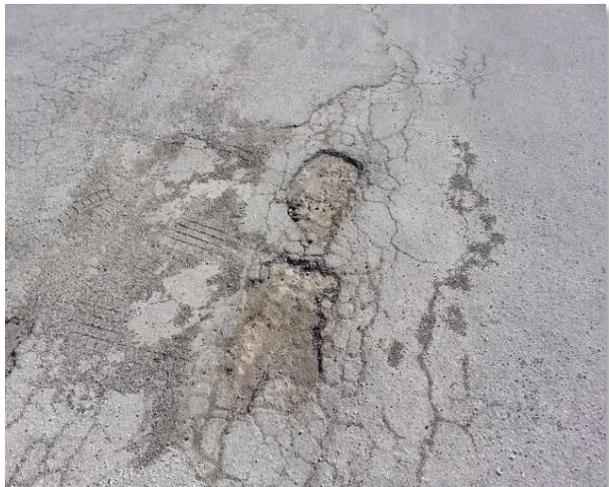
4

The grounds have not been maintained very well in recent history. Areas of erosion and uneven ground were noted. See below for the details and maintenance recommendations. The parking area is also quite badly deteriorated with several large patches and areas of damaged and uneven asphalt. Budget to rework the parking area quite extensively in the near future.

Example of damage to the parking areas

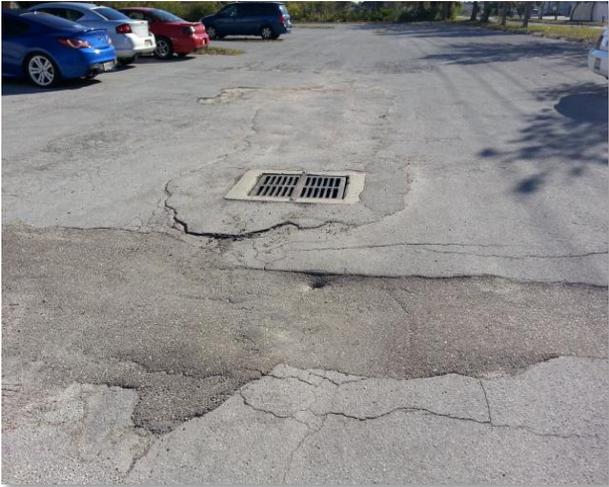
5

Example of damage to the parking areas

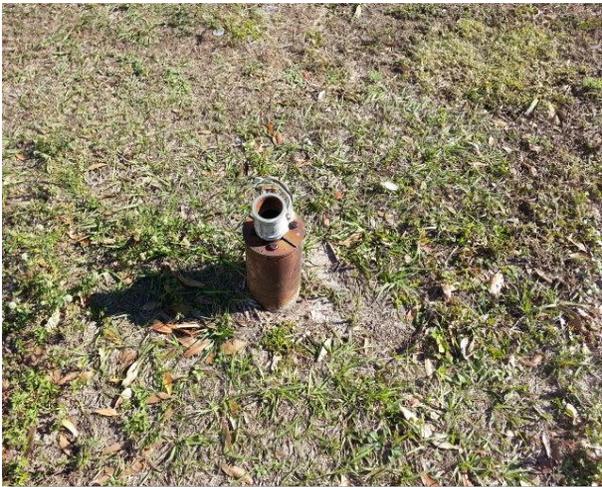
6

Suspected old well point

- 1 There is what appears to be an old disconnected well point in the SE corner of the property that should be removed.
- 2 The irrigation system is not operational. Many broken heads were noted and the wiring at the control box is exposed and damaged. Anticipate the need to completely refurbish the irrigation system.
- 3 The retention area on the far east side of the property is heavily overgrown and needs to be cleared to ensure proper operation.
- 4 Extensive erosion down the north side of the main building needs to be corrected at this time.
- 5 Deep erosion at the front of the building at roof drains should be corrected at this time. Also, the drains should be extended out further away from the base of the walls.

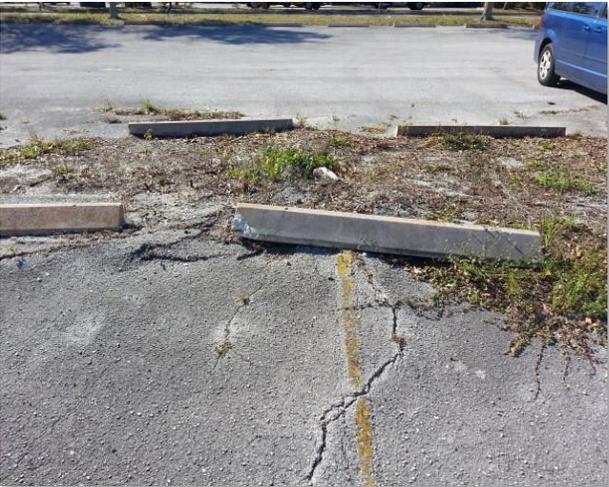
7

Damage to parking areas

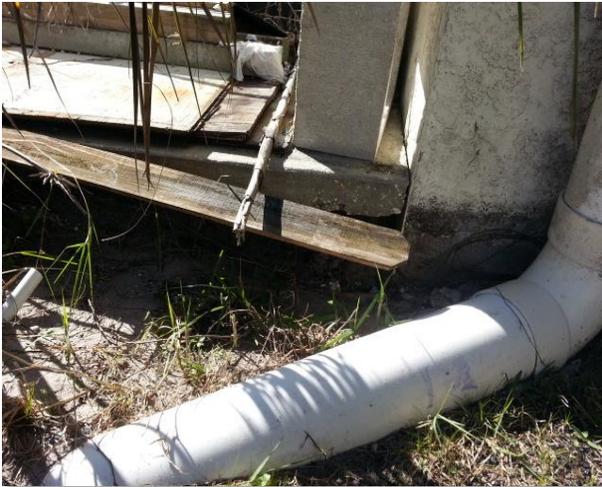
8

Heavy erosion at the NE corner

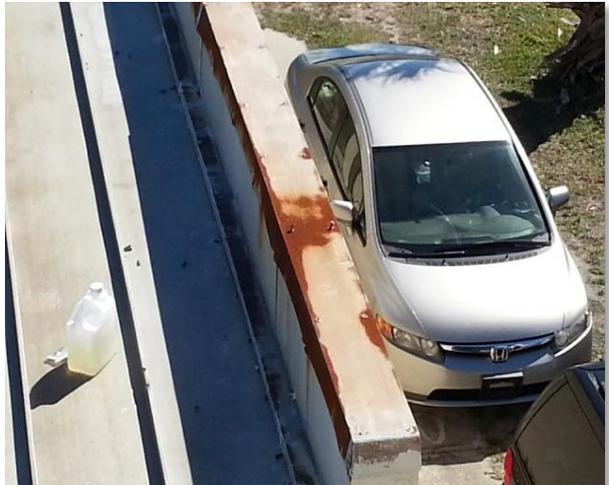
4

Deterioration to the accessory structure parapet cap flashing

- 1 Short parapet cap flashing at the far SE corner of the accessory structure was noted and needs to be corrected. The parapet cap flashing on this roof is generally in poor condition and it may be wise to simply replace it at this time.

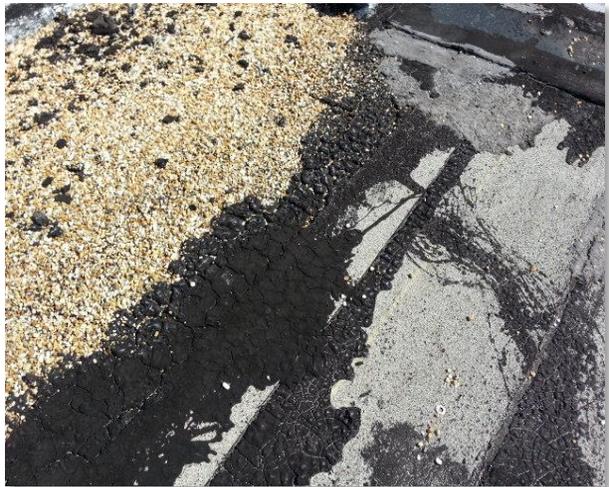
6

Deteriorated and crude intersection of gravel and older mod. bit. roofs

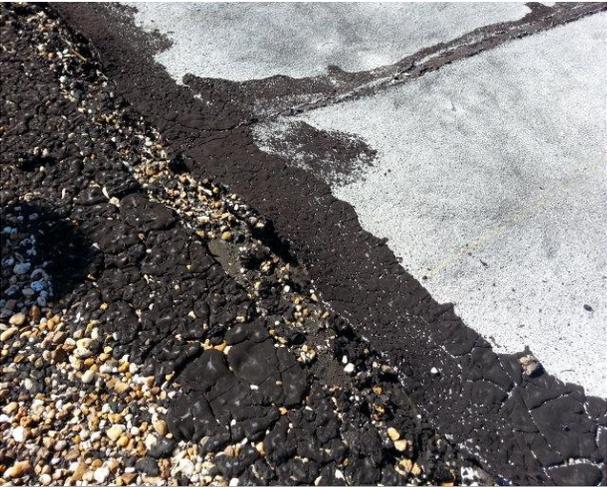
7

Example of many lifting sections of mod. bit.

- 3 Extensive debris storage on the main roof needs to be cleared for safety.
- 4 Numerous areas of very heavy deterioration were noted to the older modified bitumen membrane. Lifting membrane, crumbling membrane, bubbling, depressions that hold water, reverse laps, etc. were noted. In general, the older modified bitumen has completely failed and needs to be replaced.

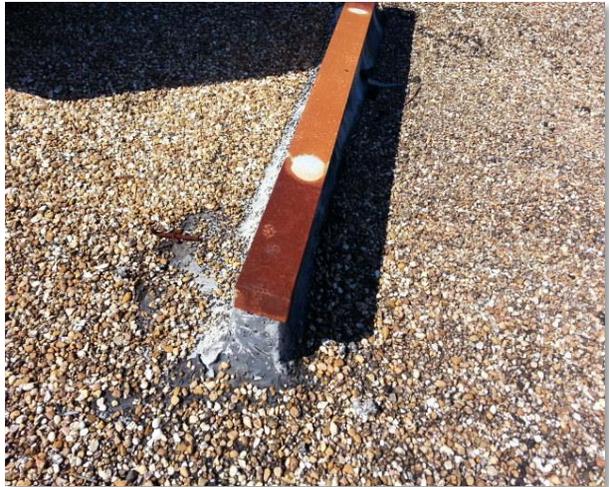
8

Example of badly rusted flashings

- 5 Most metal flashings at the various curbs and parapet walls are badly rusted and should be repaired or replaced at this time.
- 6 Missing and damaged parapet flashing at the far West side of the building needs to be corrected.

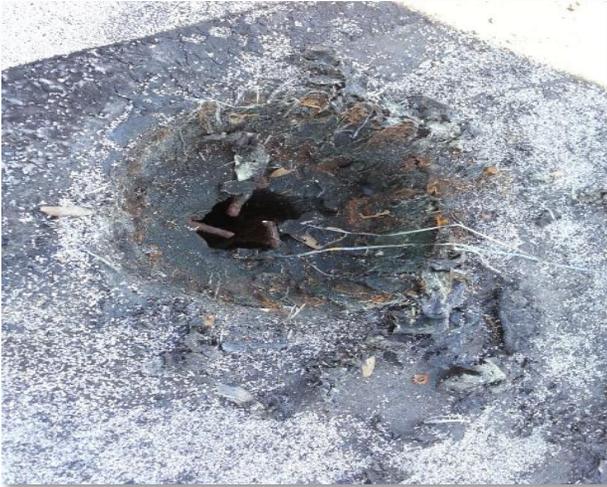
9

Roof drains are badly deteriorated

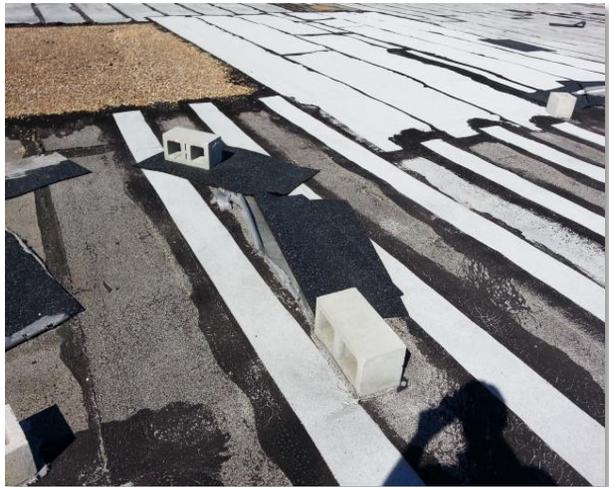
10

Example of widespread and poorly installed patches to the roof

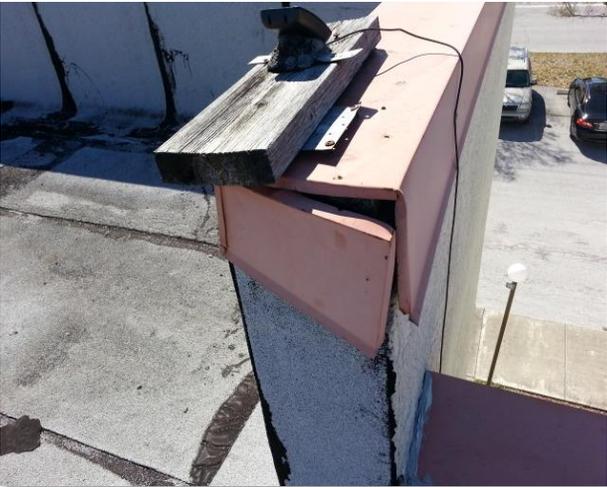
11

Loose cap flashing at the west side over the front entry

- 7 Split and open membrane was noted at the parapet walls at the SW section of the building.
- 8 There is a section of loose parapet flashing over the front entry area West side.

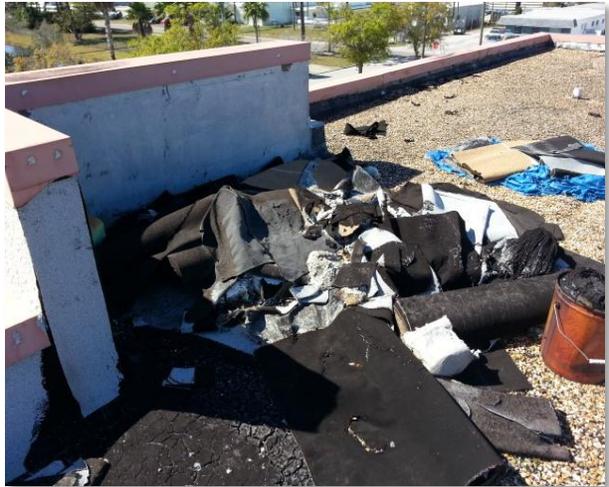
12

Piles of debris on the roof need to be removed

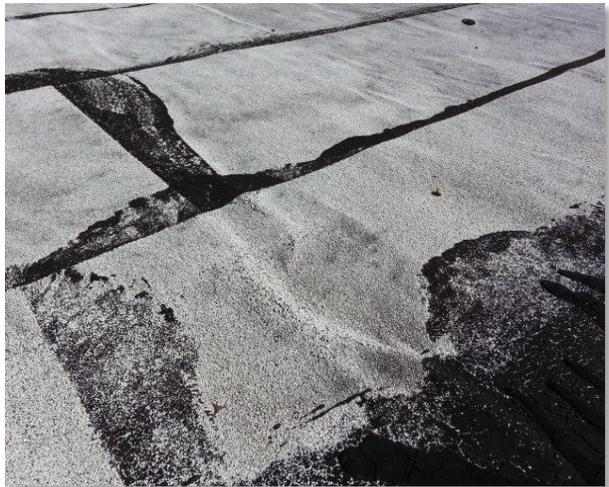
14

Very uneven roof deck

- 1 I strongly recommend fully cleaning and sealing the metal roof on the detached accessory structure. This should be done soon in order to extend the life of this roof surface.
- 2 Extremely uneven roof decking was noted and I strongly suspect that fiber boards installed on top of the metal deck are badly deteriorated. Budget to replace many boards when the roof is replaced.

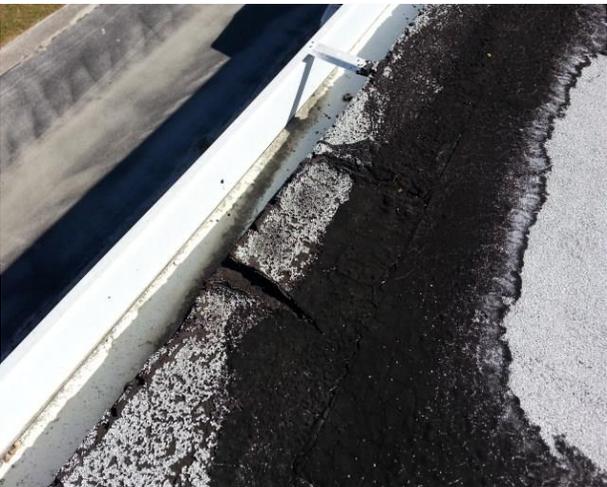
15

Depressions at the deck hold water

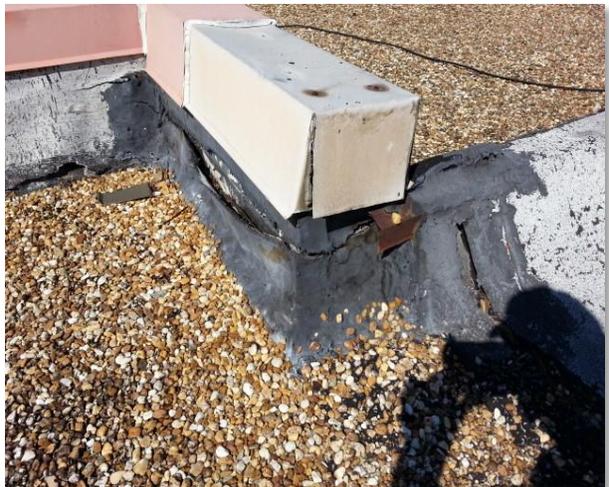
16

Deteriorated and open membrane at the west side parapet walls

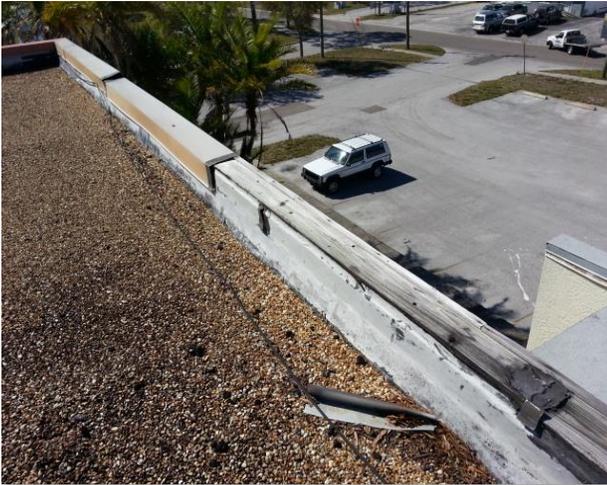
17

Missing and damaged cap flashing at the far west side of the roof

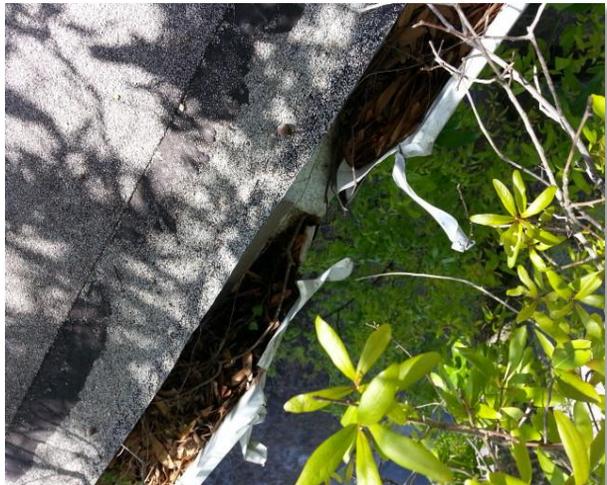
18

The gutter system needs to be replaced at this time

- 2 The north wall gutter system is badly damaged and is quite small for a building of this size. I recommend having this gutter system completely replaced at this time.

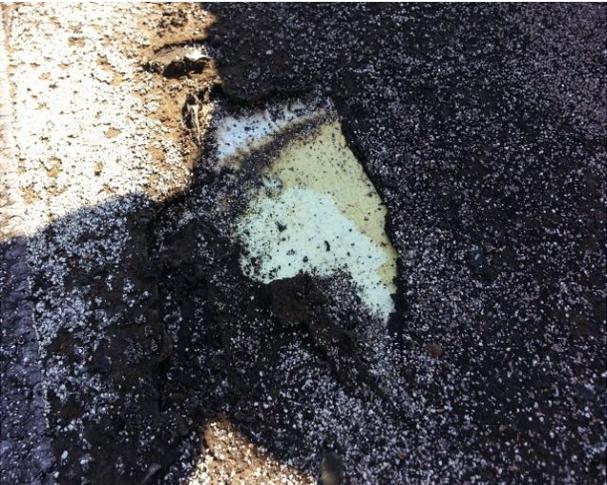
19

Old membrane has completely worn away

- 9 The issues noted above are just a few specific examples of the obvious deficiencies on the roof. It is my opinion that the roof should be replaced at this time. I recommend obtaining a second opinion by a licensed roofer.

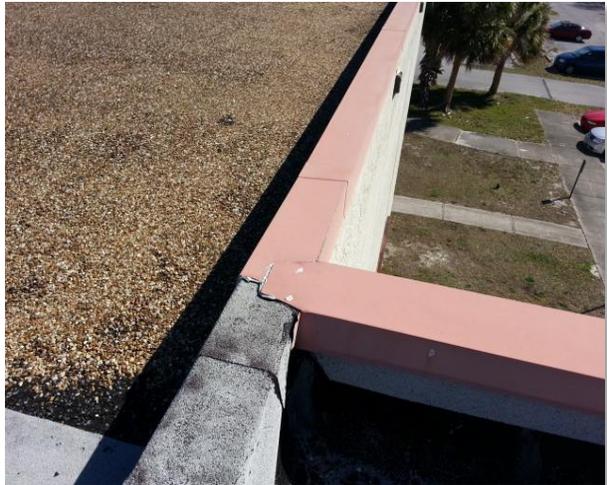
20

Poorly integrated cap flashing and membrane

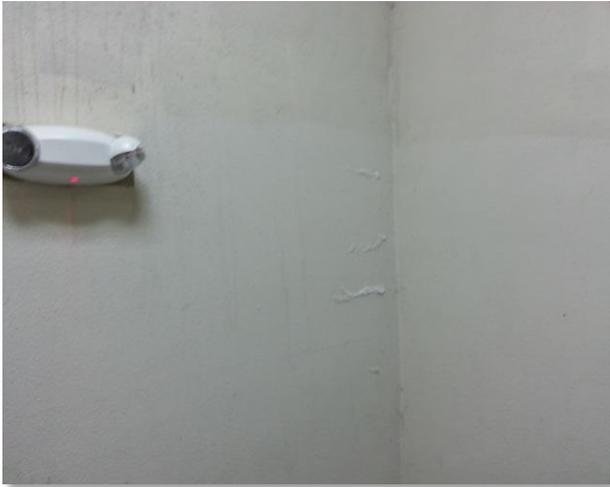
1

Water intrusion through walls

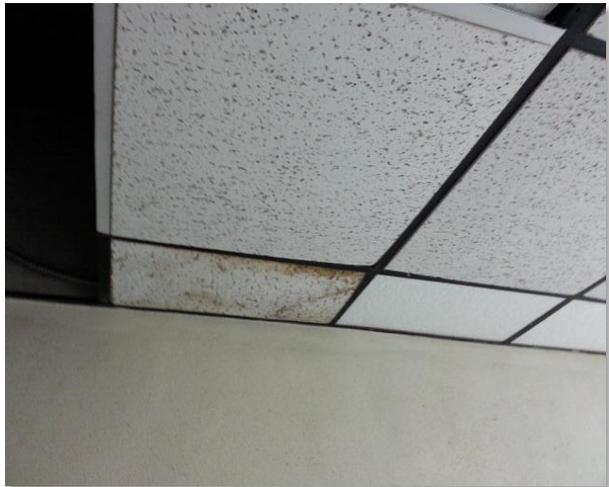
2

Numerous stained and damaged ceiling tiles

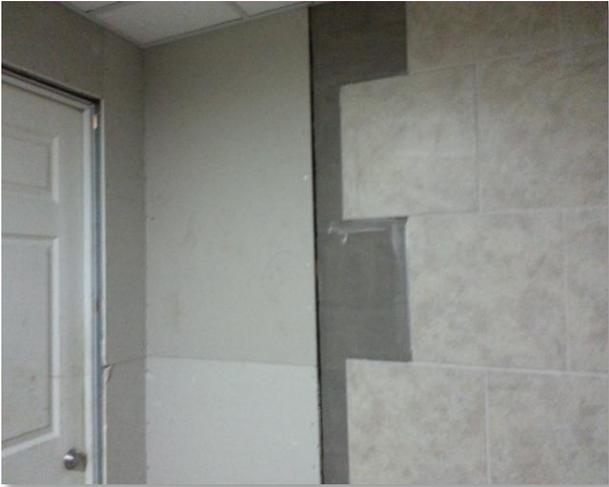
5

Example of unfinished interior trim-out

- 1 Stairwell handrails are loose and should be secured for safety.
- 2 All exposed wall framing, missing doors, unfinished construction in general, needs to be addressed for safety.

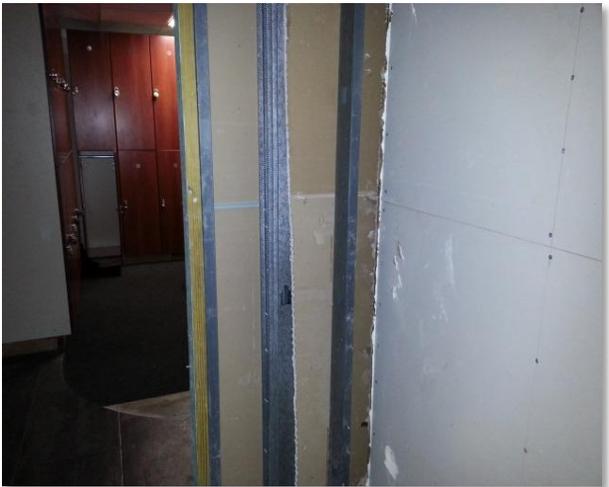
6

Example of unfinished interior wall framing

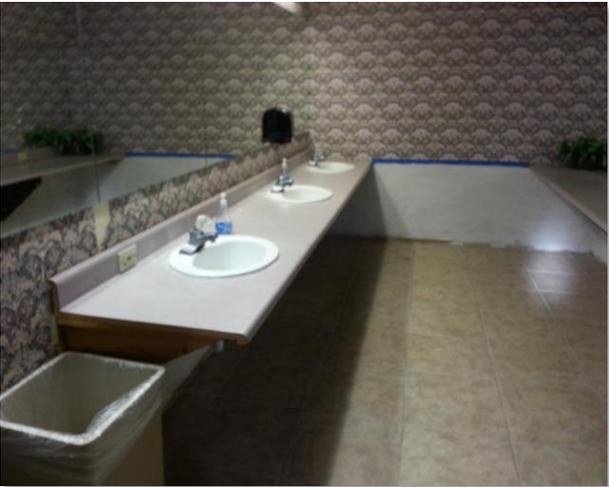
7

Ladies bathroom countertop is loose and not safe

- 4 The ladies bathroom countertops are very poorly supported and are starting to fail. These need to be corrected at this time for safety.
- 5 Replace all missing and damaged ceiling tiles as needed.

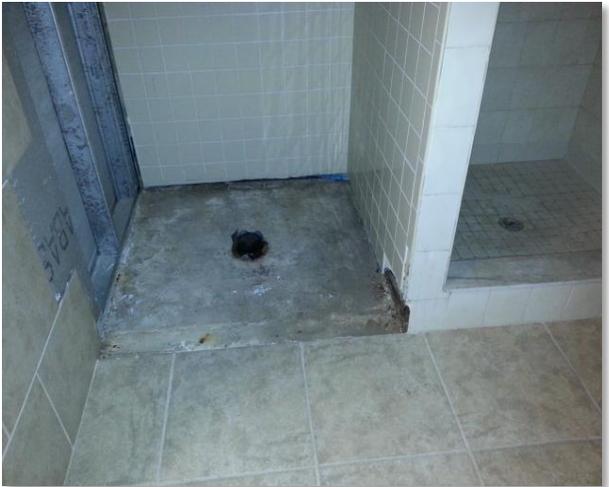
8

Missing shower in ladies bathroom

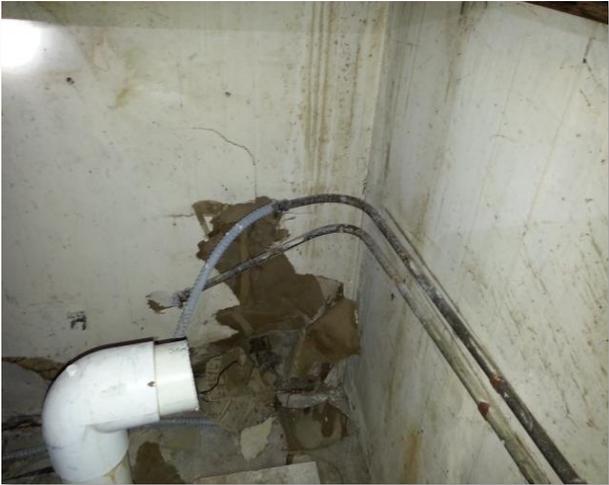
9

Water and fungal damage to the wall in the ladies Jacuzzi equipment room

- 7 Water and fungal damage to a wall in the Jacuzzi equipment room in the ladies bathroom was noted and needs to be repaired.

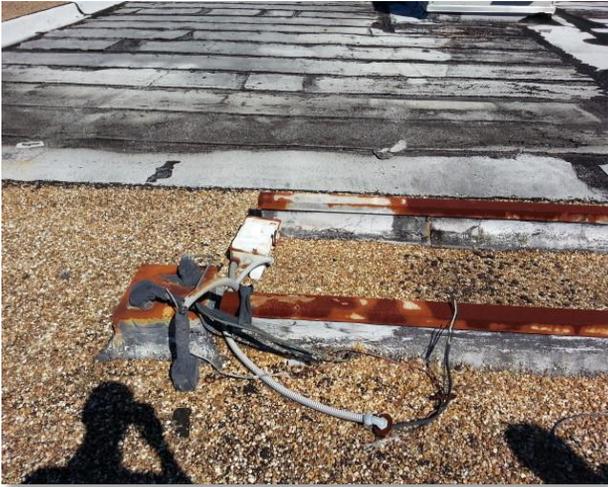
1

Exposed wires on the roof

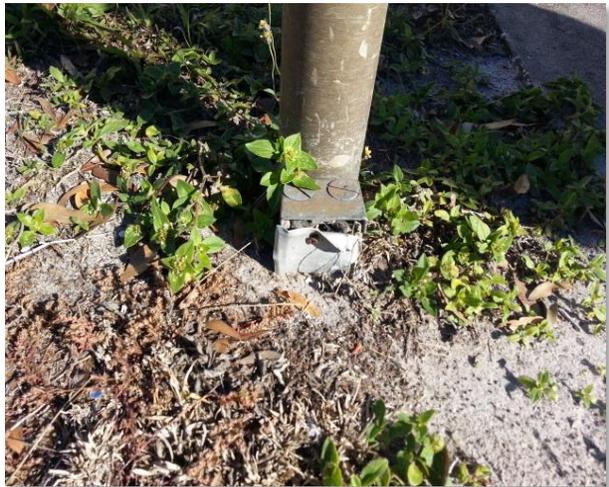
Damaged junction boxes at exterior lighting

- 1 Electrical junction boxes at the exterior front walkway lighting are all damaged and inundated with dirt. The boxes need to be reworked at this time and ideally raised.
- 2 A badly deteriorated 50 amp fuse box on the exterior north wall of the accessory structure should be removed.
- 3 Many open junction boxes and exposed wire connections were noted throughout the building.
- 4 I strongly recommend having a licensed electrician fully evaluate the system for safety and compliance and make all needed repairs and updates at this time.

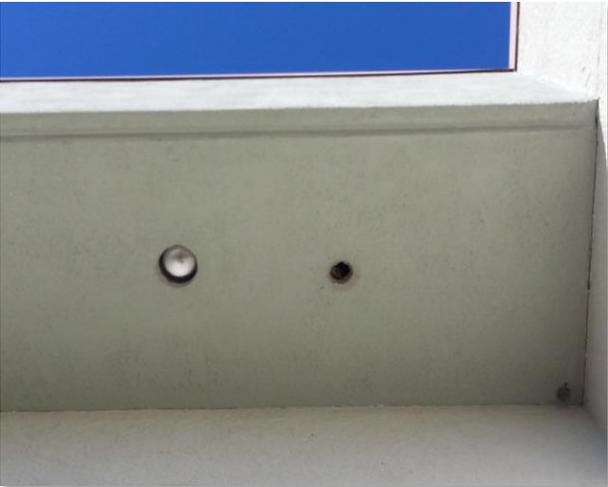
3

Poorly sealed soffit lighting

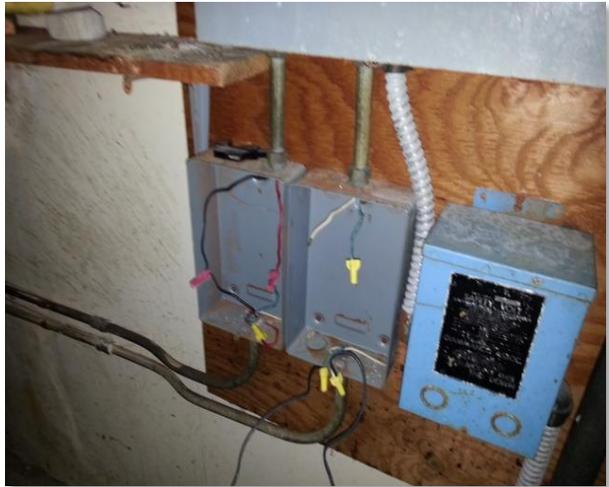
4

Example of many miscellaneous wiring deficiencies noted throughout the building
