Tampa, Florida

Thursday, October 10, 2013

Inspection Information Sheet

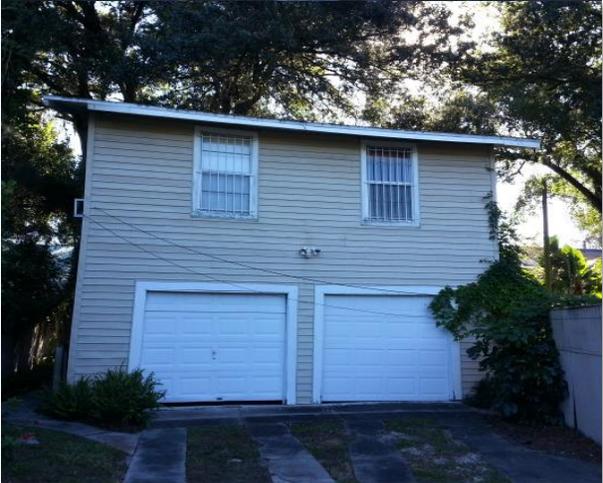
6

- 1 The garage has settled and shifted quite noticeably over the years. The structure appears to be generally leaning towards the South. The movement appears to be the result of typical settlement of the original concrete slab, water damage to the wall framing bottom plate, termite damage and the orientation of the floor joists for the second level providing little rigidity. The lean is quite noticeable and is something that should be carefully monitored in the future with the anticipation that adjustments and bracing may be required at some point. Several conditions exist at this time that hurt the overall integrity of this building and require repair - see below.

Garage view showing lean

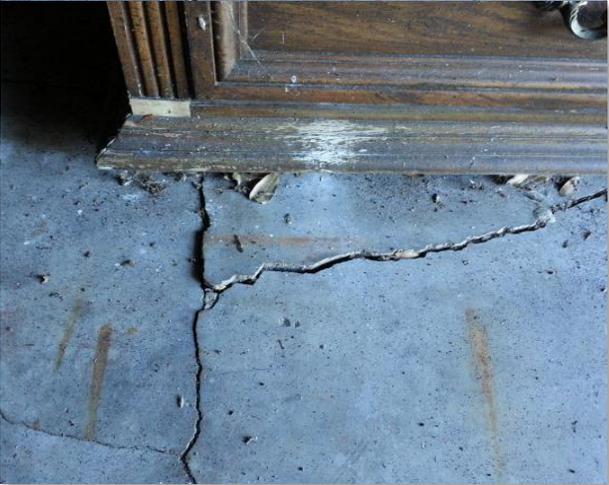
7

Cracking and settlement to the garage slab

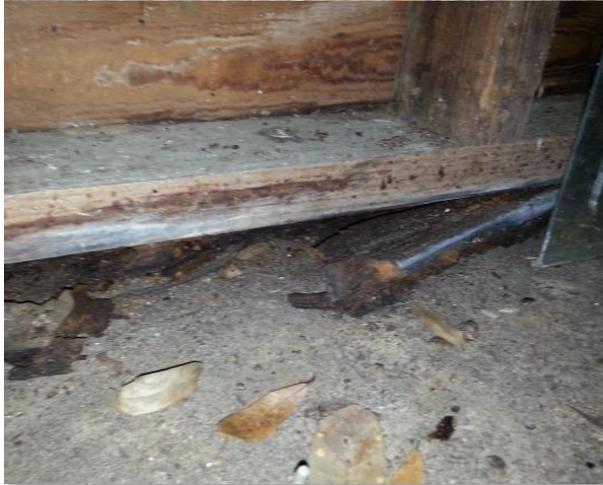
8

- 1 Several areas of badly rotted, compressed and missing bottom plate were seen inside the garage as a result of water intrusion around the base of the walls. This has caused some movement of the structure in conjunction with several other areas of heavy termite damage that were seen to wall and floor framing. I recommend having a framing contractor or structural specialist fully evaluate the garage structure at this time and make all needed repairs.

Rotted away bottom plate at garage wall framing

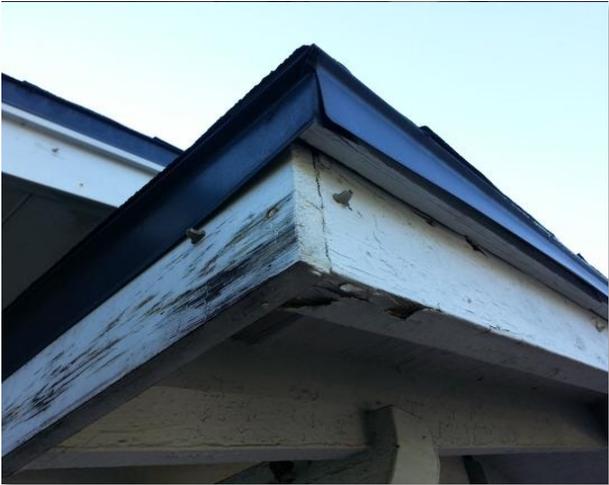
1

- 2 All exterior wooden trim was found to be in poor condition with painting and caulking improvements needed at this time. Several areas of wood repair or replacement will be needed, the most significant areas are detailed below.

Deterioration to wood trim elements

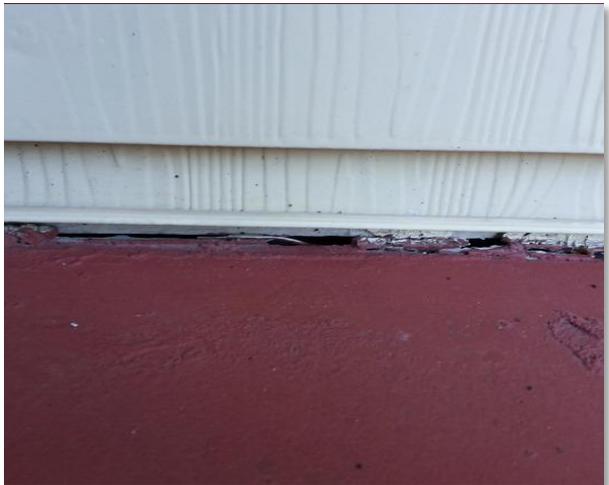
2

- 1 It is very important to keep the intersection of the front porch and front wall of the home well sealed to prevent water intrusion; improvements should be made to this area at this time. Additionally, evidence suggests that this front porch slab has moved relatively recently. Cracking should be sealed and the porch slab should be painted to help reduce the likelihood of water intrusion and erosion underneath the slab.

Seal intersection of front porch and house

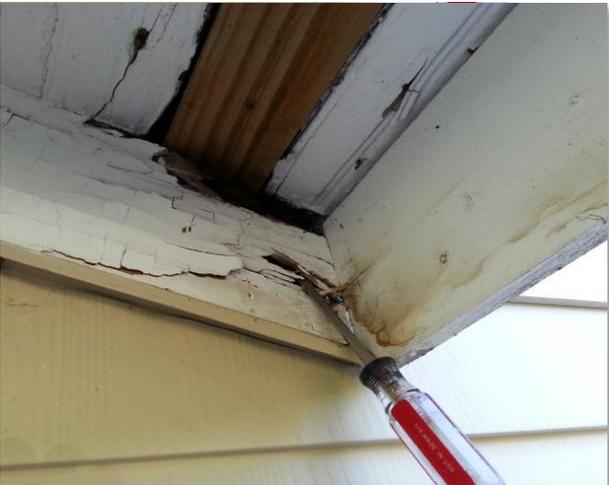
3

- 1 Decay was noted at the front porch roof system at the rafter against the wall of the home to the right side of the door. Lack of appropriate flashings at these roof return details is allowing water intrusion behind the siding and needs to be reworked at this time.

Decay at front entry roof rafter

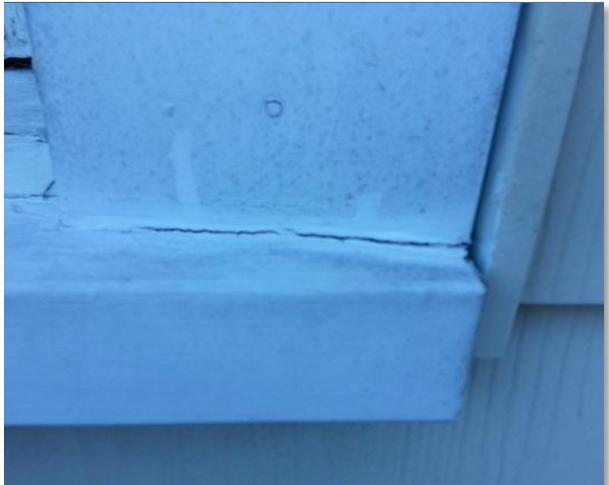
4

Keep window details well sealed

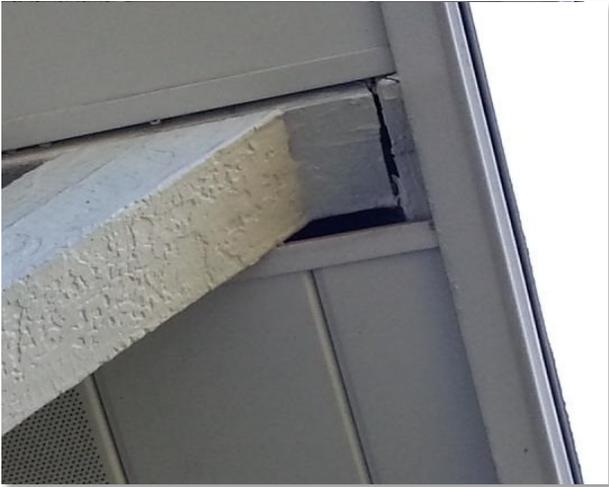
Exterior Figures

Seal around trim and soffits

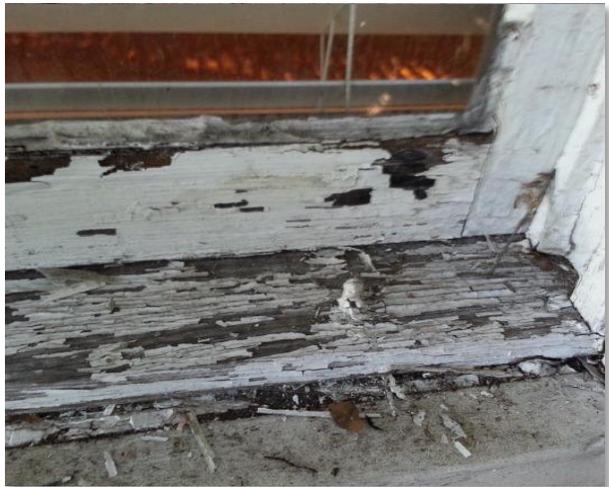
6

- 2 The rear bedroom South wall window is in particularly poor condition on the exterior and should be carefully reworked at this time.
- 3 Decay at the NW window next to the carport needs to be repaired.

Rear bedroom window is badly deteriorated

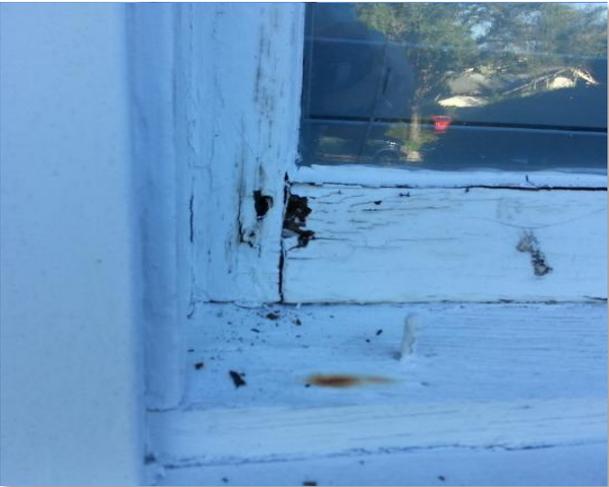
7

Decay at NW window

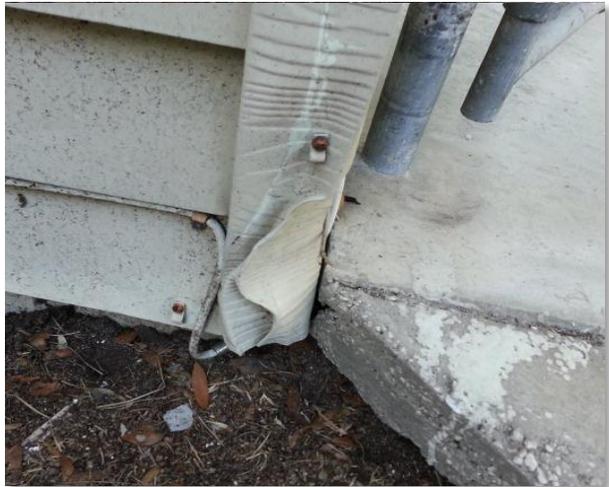
8

Miscellaneous damage to siding and trim

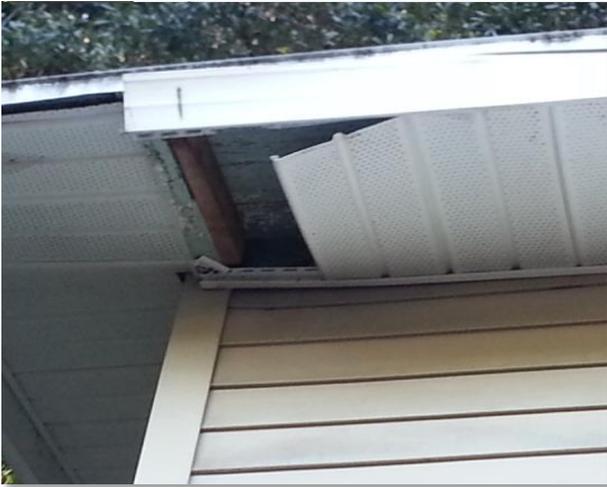
9

- 4 Decay at the base of the garage door frames and damaged trim around the garage doors and upper-level windows needs to be repaired.
- 5 Loose soffit on the West side of the garage needs to be repaired.

Loose soffit on west side of garage

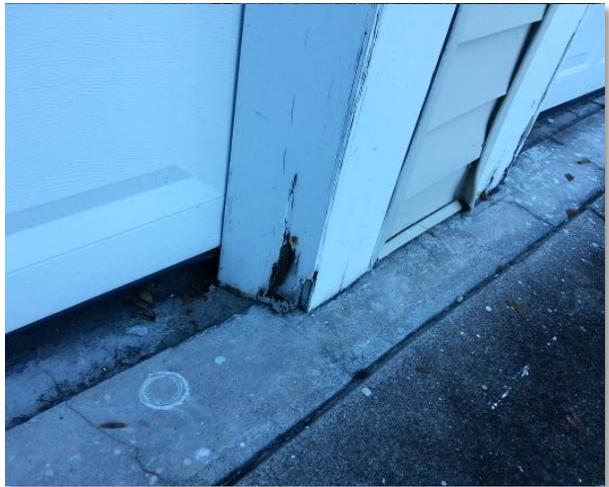
10

Decay to garage door trim

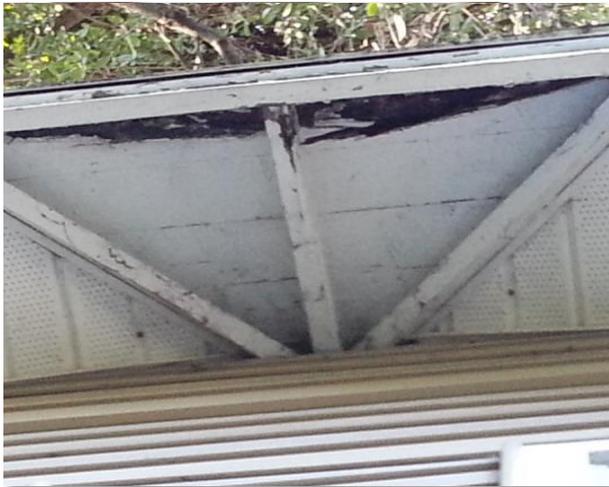
11

- 6 Damaged roof decking seen at soffit area on the north of the garage indicates roof leakage and needs to be repaired in conjunction with the roof.
- 7 The garage exterior staircase is heavily deteriorated and is not safe. The entire staircase and upper-level landing should be considered for being rebuilt at this time for safety.

Rot and leakage at garage roof north edge

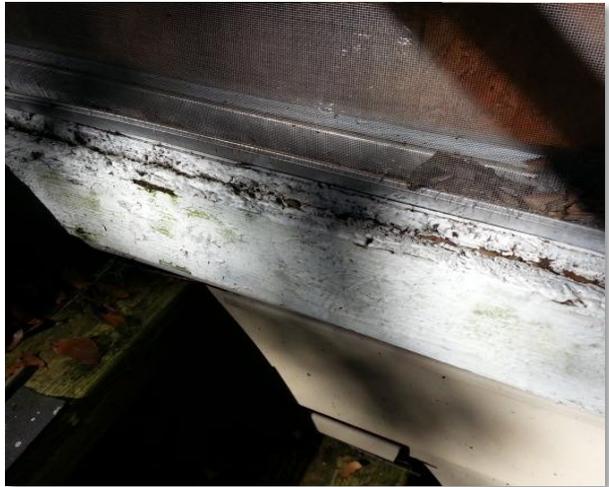
12

- 8 The garage lower rear wall North window sill is badly rotted and needs to be replaced.
- 9 There is a section of split siding on the upper front wall of the garage that should be sealed to prevent water intrusion.

Rotted rear wall garage window sill

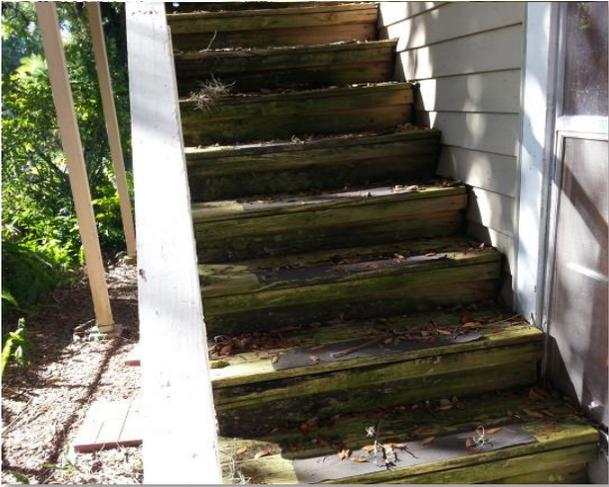
13

Garage stairs are very weak

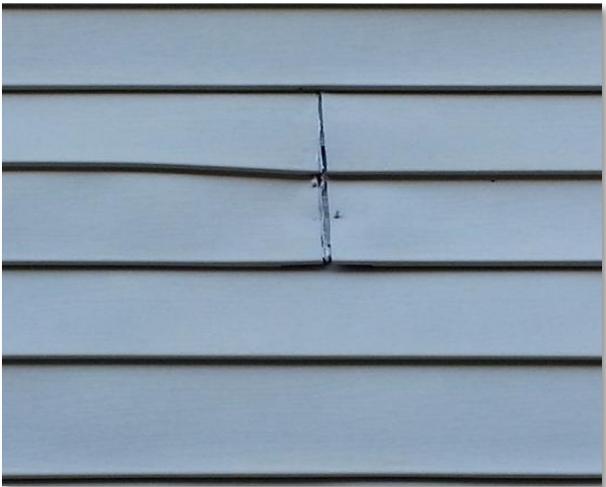
14

Split siding on upper front wall of garage

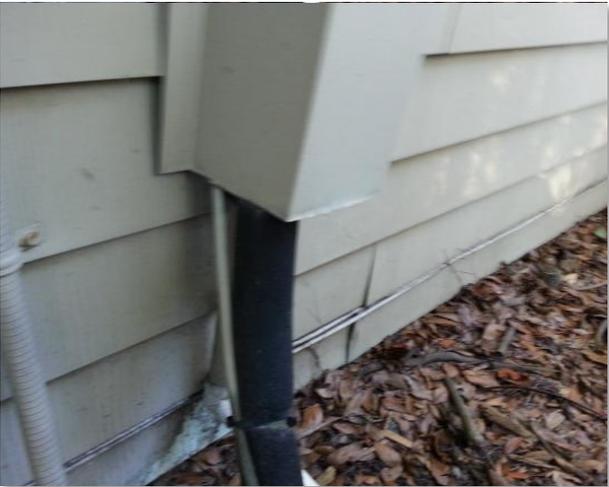
15

- 5 I recommend sealing the bottom of the AC line chase to help reduce the likelihood of animals from getting into the attic.

Seal AC line chase

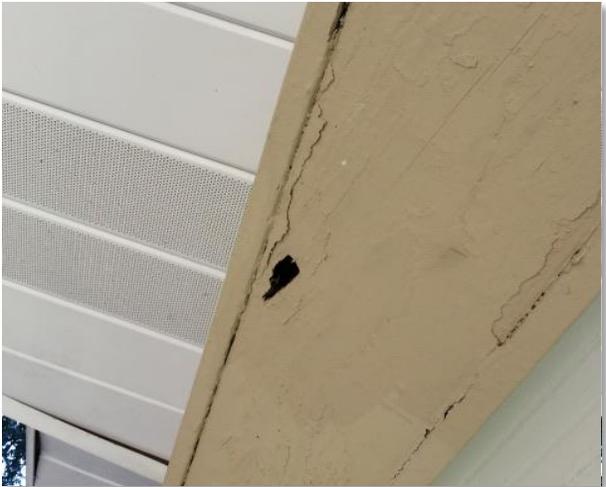
16

- 10 Damage to trim on the rear header beam over the carport was noted and should be repaired. It would be wise to open this trim to be able to inspect the structural beam.

Damage to carport rear header beam

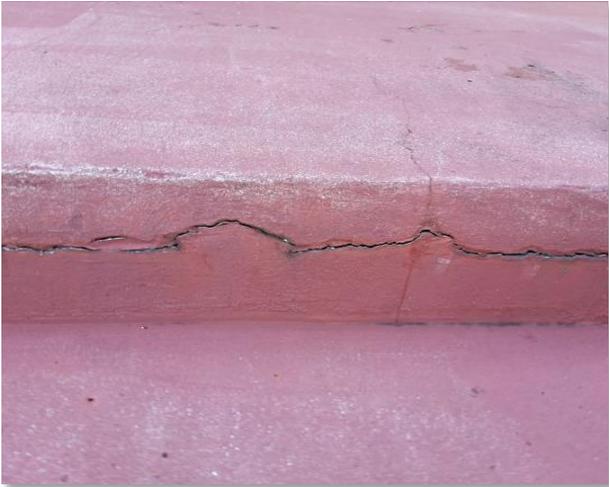
1

Cracking to front porch should be sealed soon

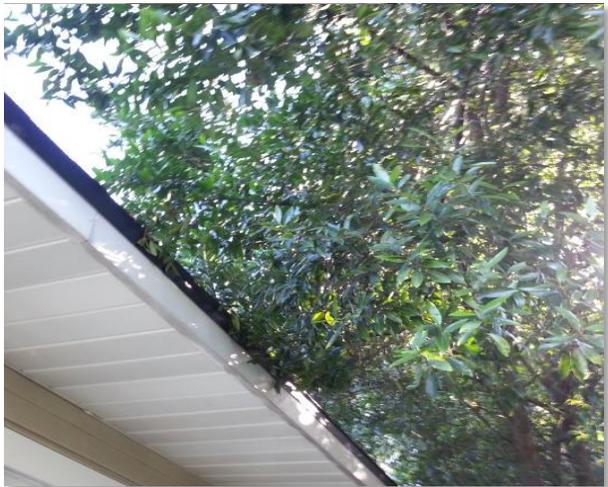
2

Trim back tree and shrubs from the house

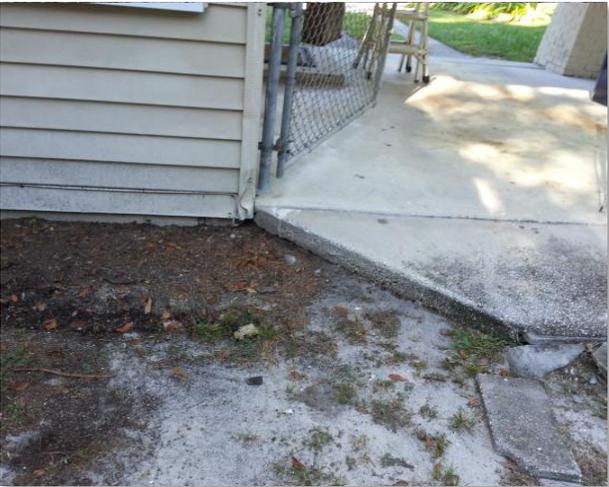
3

- 2 Erosion was noted around the perimeter of the home as a result of roof water runoff. The most notable areas that appear to trap moisture include behind the carport, across the rear wall of the home, and at the sides of the front entry porch. I strongly recommend improving the grading in these areas or considering adding a partial gutter system to better control roof water drainage. The erosion behind the carport has started to undermine part of the concrete slab and should be addressed at this time.

Erosion behind carport

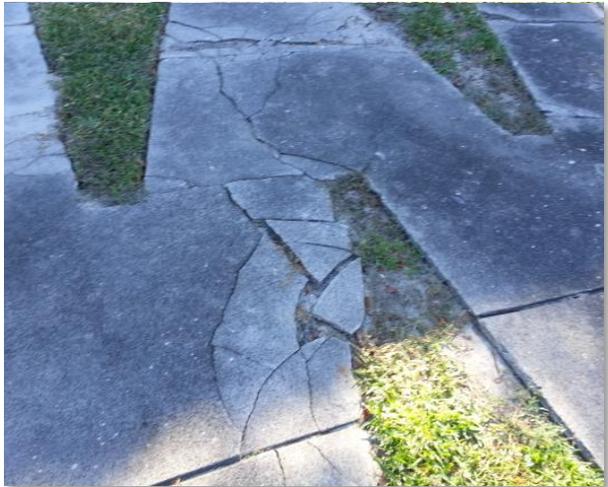
- 3 Much of the rear driveway is badly cracked and should be considered for replacement in the future.
- 4 Negative grading in the rear of the garage as a result of the large tree and tree debris buildup over the years is projecting water towards the structure and should be addressed in the near future.

Damage to drive

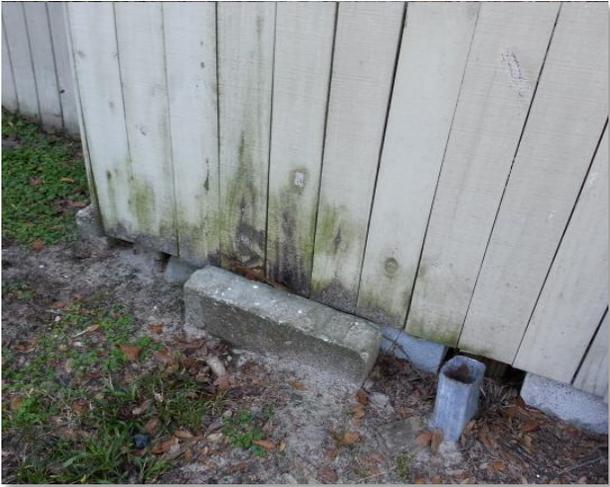
5

- 1 The fencing was found to be deteriorated with mildew damage and broken boards. Having the fencing cleaned and sealed at this time would help to extend its life but some replacement of fence material will be needed soon.

Deterioration to fencing

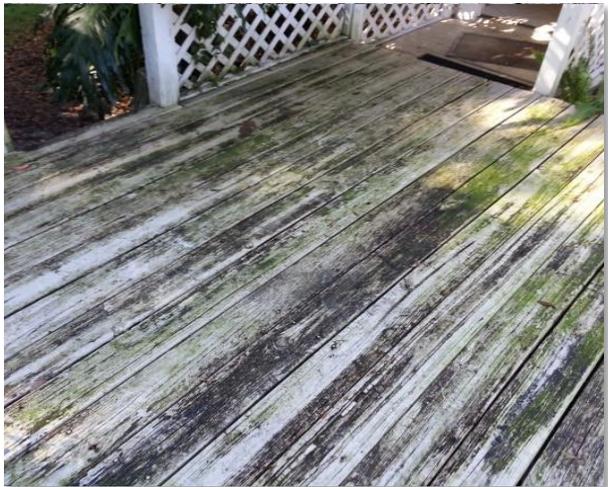
6

- 5 I strongly recommend cleaning and sealing the wooden deck in the rear of the property at this time in order to help extend its life.

Deterioration to rear deck

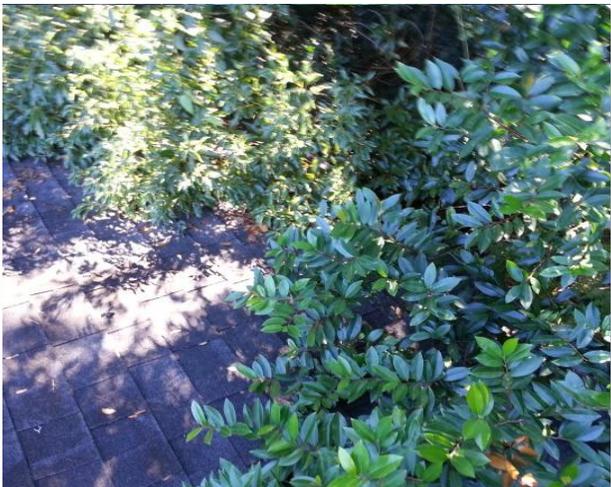
3

Tree contact on roof

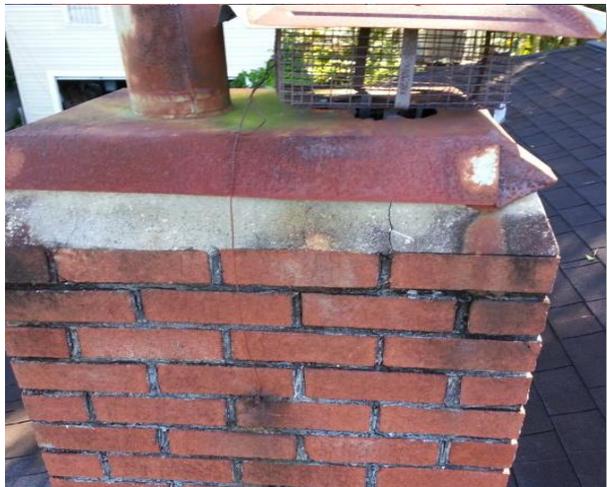
4

- 1 The chimney was found to be generally deteriorated with weak and dirty mortar, deteriorated flashing sealant, and a very old and rusted chimney cap. I strongly recommend having the chimney reworked in the near future.
- 2 Several roof penetrations on the main house are sealed with pitch pans; the sealant in these units is deteriorated and should be reapplied soon.

Deterioration to chimney

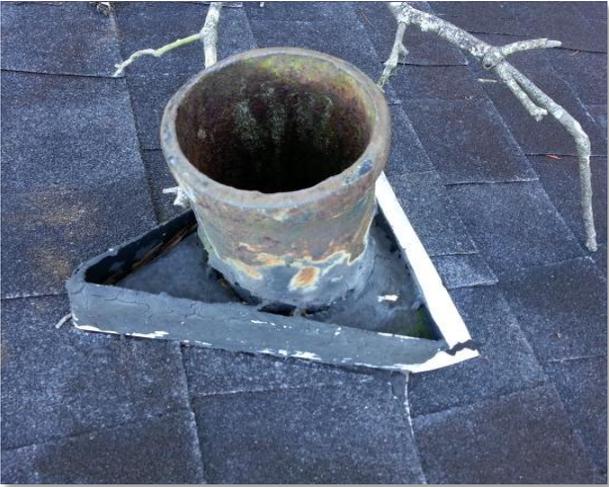
5

Improved sealant needed at pitch pans soon

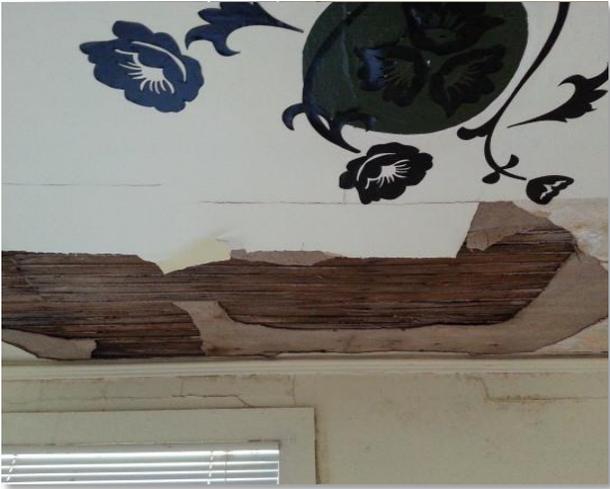
- 1 Several areas of cosmetic damage were seen to walls and ceilings in the apartment as a result of the structural movement that has taken place in this building. Additionally, water intrusion from roof leakage has caused damage and fungal growth. Some repairs are needed at this time to correct the plaster damage but it would also be wise to consider removing additional plaster in the affected structural and water damaged areas for better interior finish and to remove any material affected by fungus.

Water damage to plaster in apartment

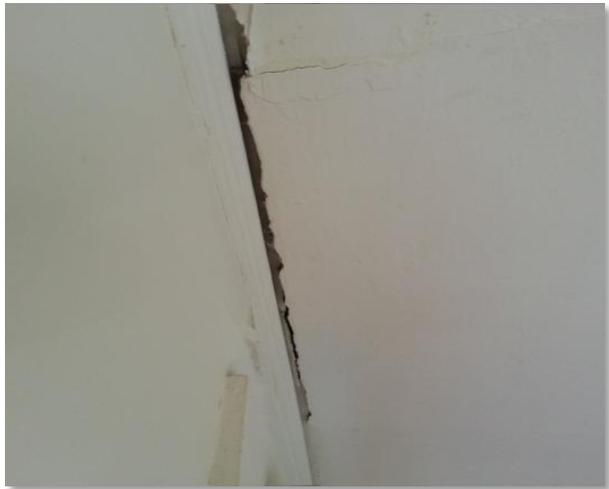
2

Settlement damage to plaster in apartment

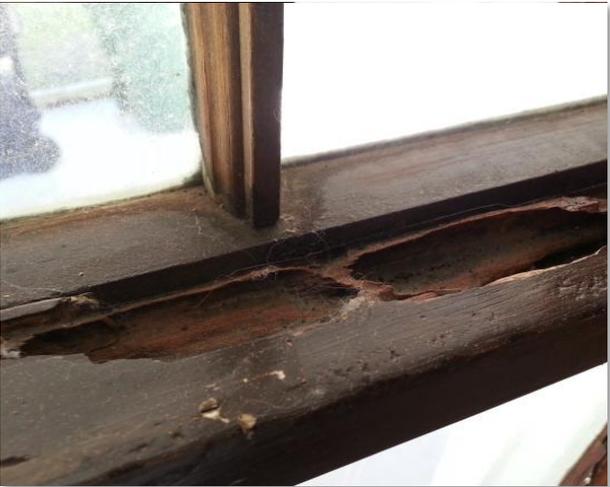
3

- 2 Cosmetic termite damage was found on both the interiors of the main house as well as the apartment. Some of the damage has caused deterioration to flooring and trim and cosmetic repairs would be wise.

Example of termite damage to windows and other trim

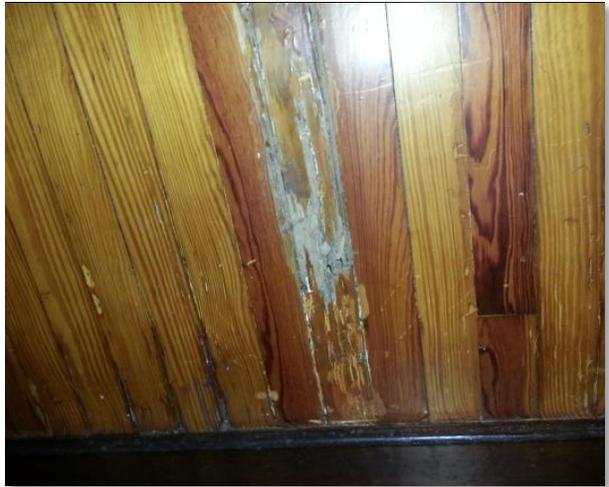
4

Badly damaged flooring in rear bedroom

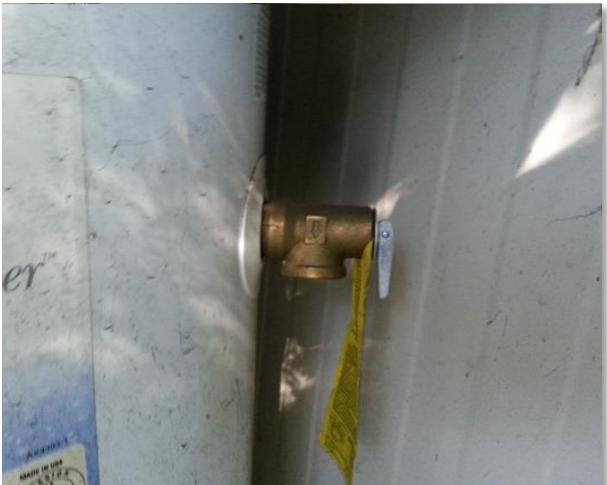
2

Missing TPR extension pipe

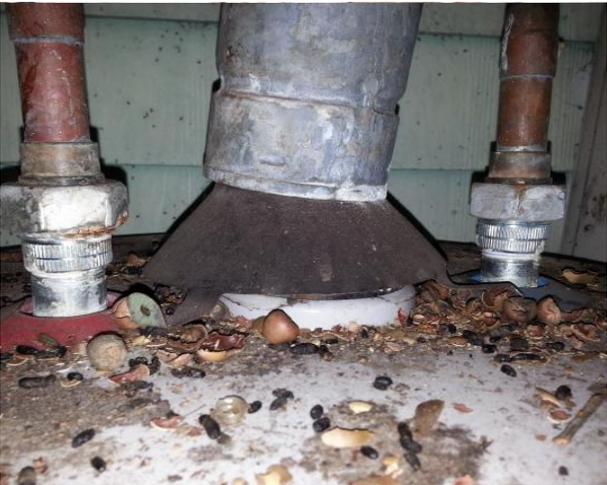
- 3 The vent on top of the main house water heater is improperly installed and needs to be corrected by a licensed plumber for safety.
- 4 The apartment toilet leaks badly when flushed and needs to be corrected.

Improperly installed vent at main house water heater

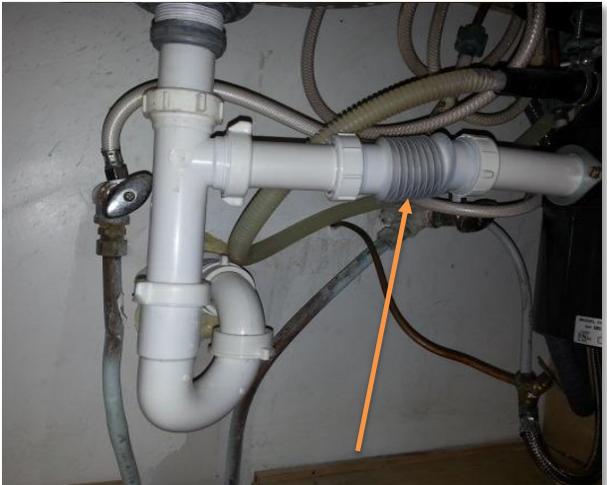
4

Corrugated piping under kitchen sink

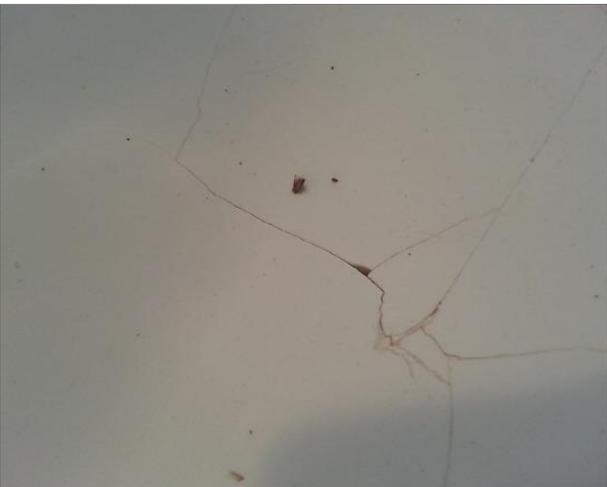
7

Damaged apartment sink

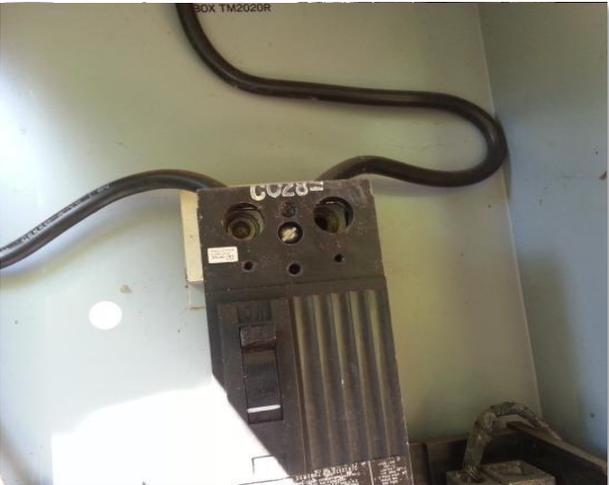
3

Over-sized breaker at garage service panel

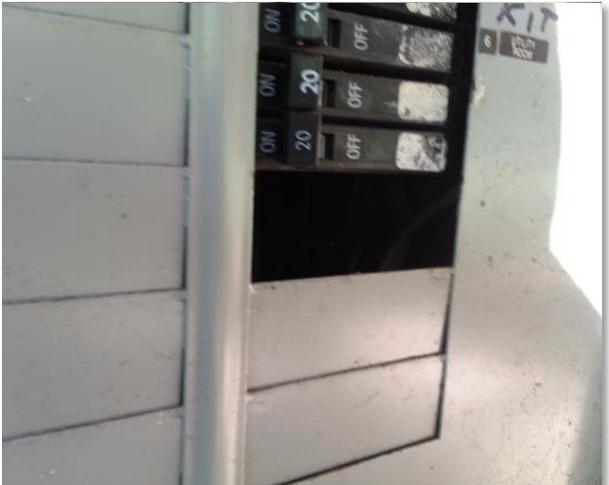
- 1 Missing knock-out at the garage main electric panel needs to be replaced.
- 2 The main breaker for the garage service is 200 A. This is oversized considering the size of the main service wire and should be corrected by an electrician.
- 3 Many exposed wires in the garage should be protected behind paneling or in conduit.
- 4 The AC condenser unit disconnect box is missing a knock-out on the side and should be corrected. This box is starting to rust aggressively and should be considered for replacement soon.
- 5 Active knob and tube wiring was found in the apartment. Have an electrician replace all such wiring as needed at this time.

Missing knock-out at garage service panel

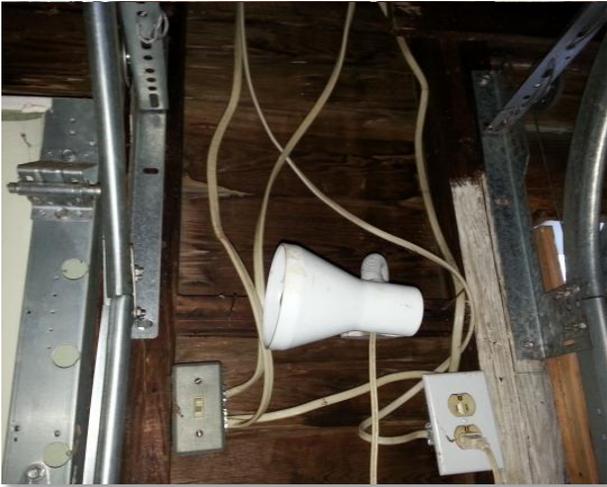
5

Many exposed wires in garage

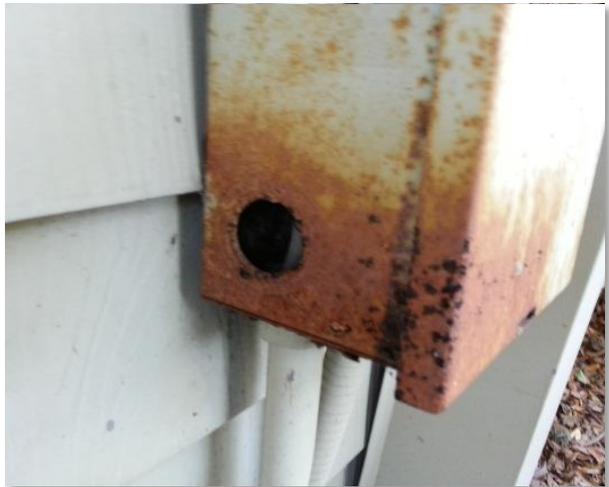
6

AC disconnect has missing knock-out and is badly rusted

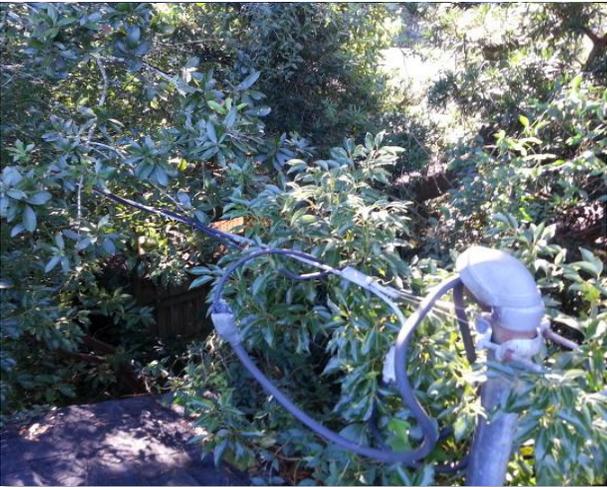
7

Main service wire going through trees

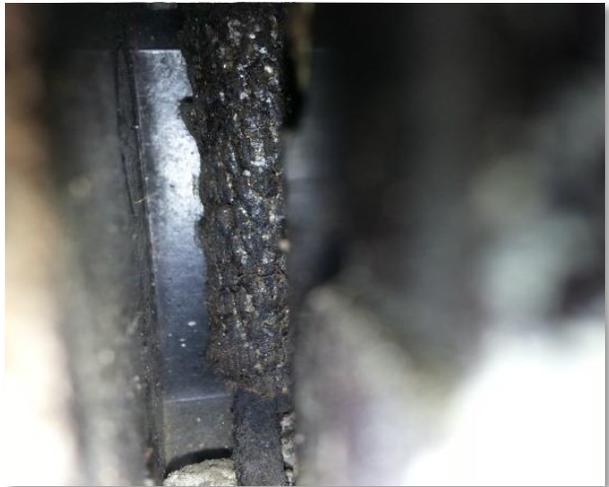
8

Knob and tube wiring seen in the apartment

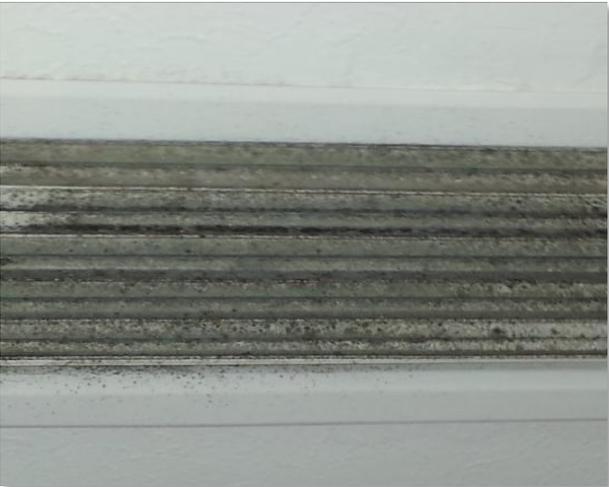
3

Example of mildew on AC registers

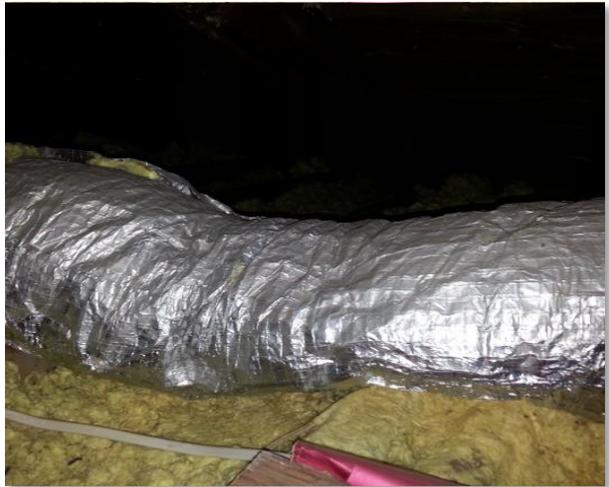
4

Example of deteriorated ducting in attic
